REPAIR, EVALUATION, MAINTENANCE, AND
REHABILITATION RESEARCH PROGRAM

TECHNICAL REPORT REMR-CO-4

STABILITY OF DOLOS AND TRIBAR OVERLAYS
FOR REHABILITATION OF STONE-ARMORED
RUBBLE-MOUND BREAKWATER AND JETTY
TRUNKS SUBJECTED TO BREAKING WAVES

February 1988

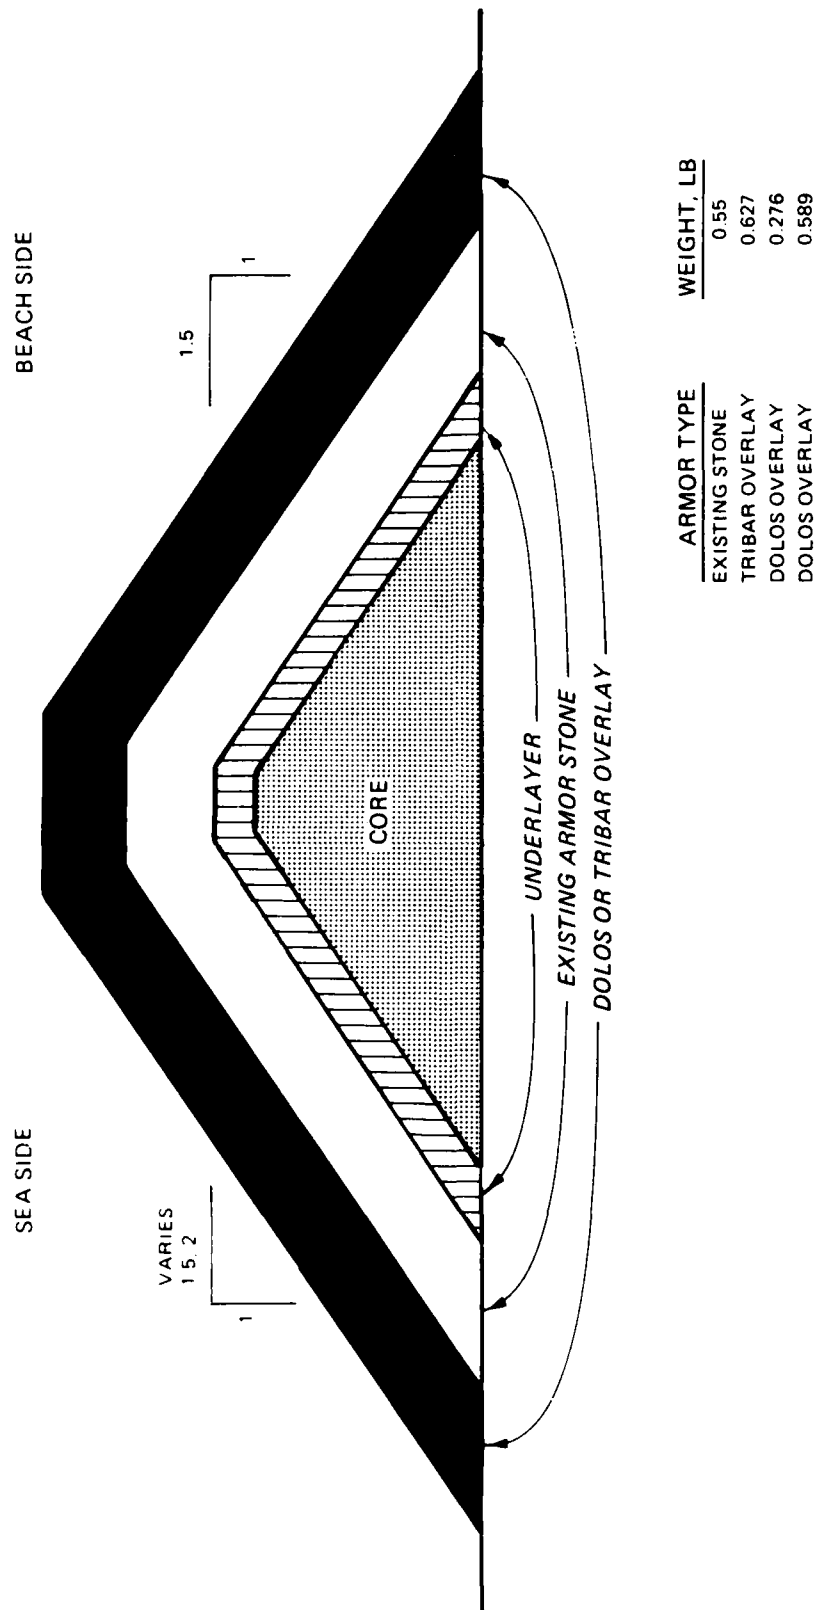
Figure 1. Typical breakwater cross section

17. All stability tests were conducted on sections of the type shown in Figure 1 and Photos 1-3. Sea-side slopes of 1V on 1.5H and 1V on 2H were investigated while the beach-side slope was held constant at 1V on 1.5H. Heights of the simulated existing structures (prior to placement of the dolos or tribar overlays) varied from 1.0 to 1.4 ft. The height necessary to prevent wave overtopping of the existing structure was determined from slopes and estimated water depths and wave heights to be investigated in determining stability coefficients (K'_D 's) for the dissimilar armor overlays.

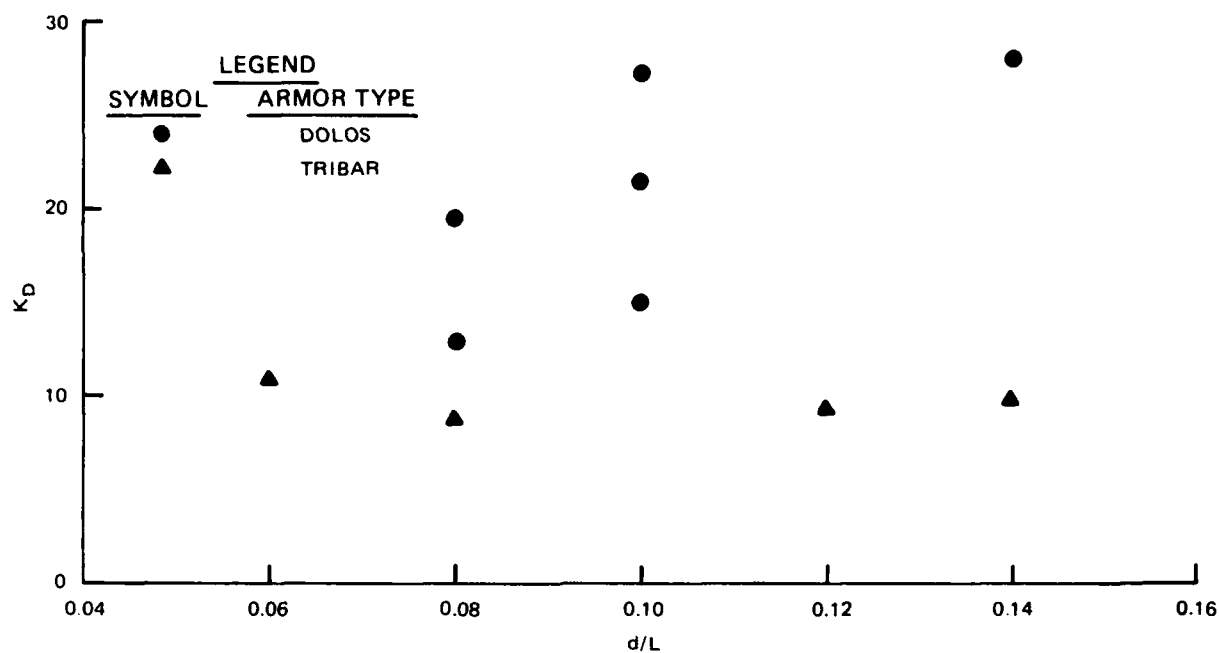
Figure 2. Stability coefficient K_D versus relative depth d/L
 $\cot \alpha = 2.0$

20. Figures 2 and 3 present K_D as a function of d/L and H/d , respectively. These data show dolos stability to be sensitive to both d/L and H/d with minimum stability occurring at the lower values of d/L and higher values of H/d , i.e., longer wave periods in shallower water. These trends are consistent with those observed by Carver (1983) for dolos used in new construction. Influences of H/d and d/L on tribar stability do not appear to be significant in the present data. The minimum K_D observed for tribars is equal to that obtained for new construction and to that observed for dolos is about 15 percent less (12.8 versus 15).

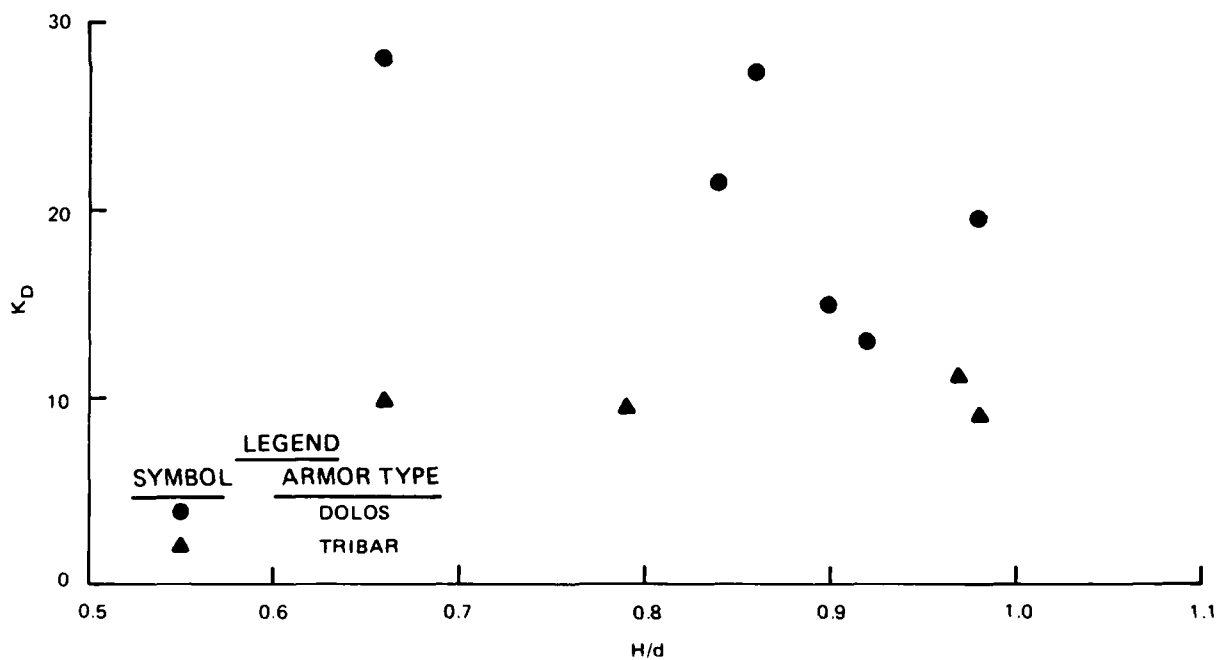
Figure 3. Stability coefficient K_D versus relative wave height H/d
 $\cot \alpha = 2.0$

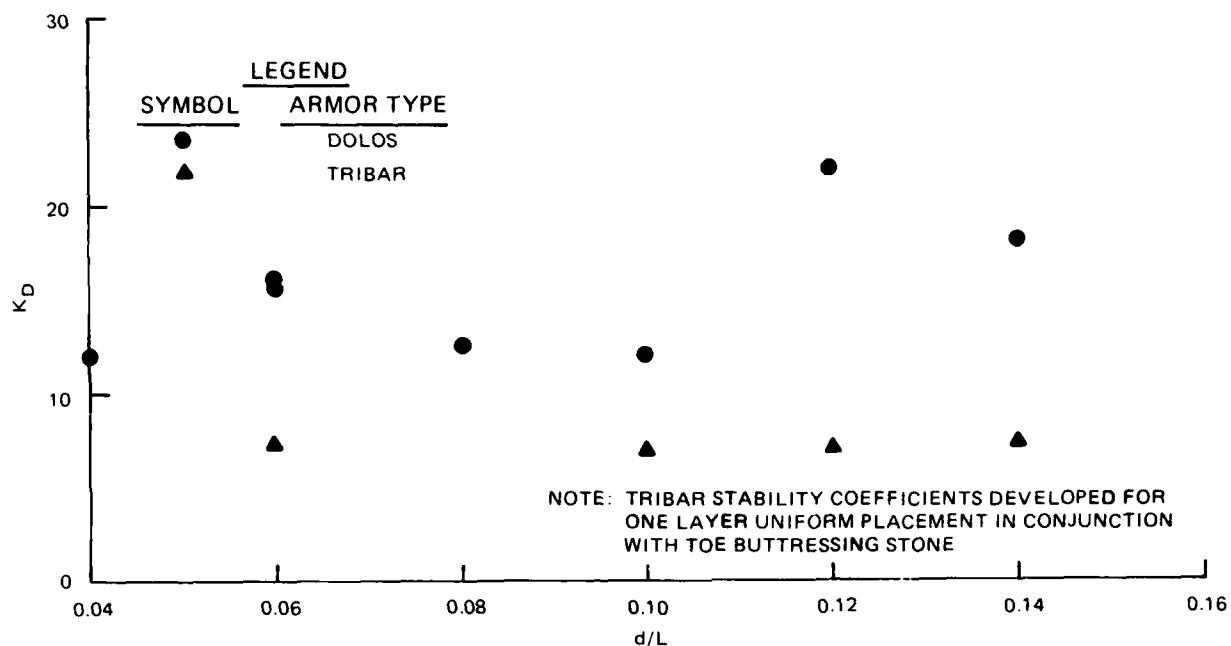
Figure 4. Stability coefficient K_D versus relative depth d/L
 $\cot \alpha = 1.5$

24. Results of stability tests for the uniformly placed tribars are summarized in Table 2 along with the previously discussed dolos test results. These data indicate a minimum stability coefficient of 7.0 for the uniformly placed tribars. Figures 4 and 5 present K_D as a function of d/L and H/d , respectively. Similar to results for the 1V-on-2H slope, dolos stability proved to be sensitive to d/L and H/d with minimum stability occurring at the lower values of d/L and higher values of H/d and tribar stability was not significantly influenced by either d/L or H/d .

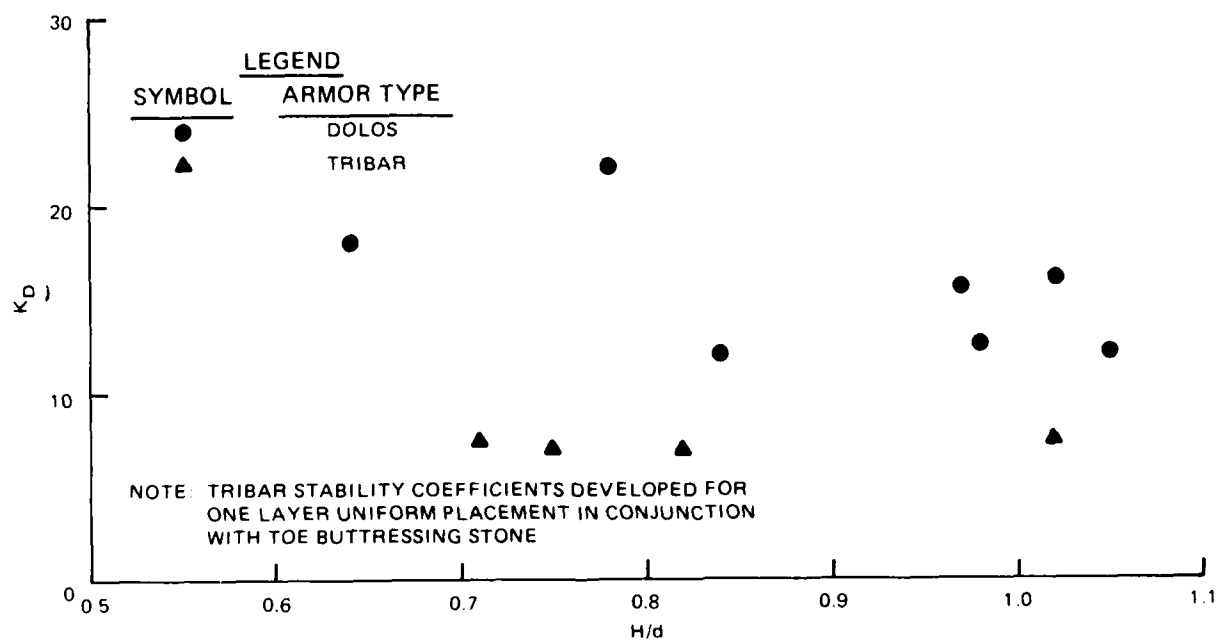
Figure 5. Stability coefficient K_D versus relative wave height H/d
 $\cot \alpha = 1.5$

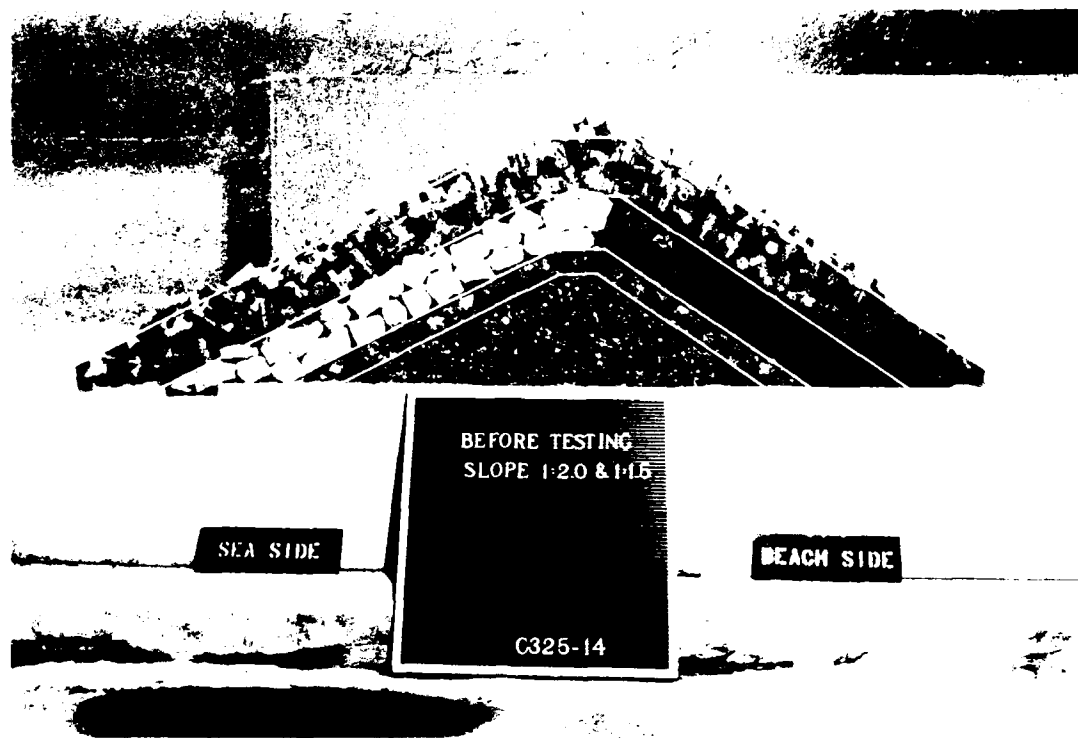
Photo 3. End view of a typical tribar section before wave attack at a 1V-on-2H sea-side structure slope; $W_a = 0.627 \text{ lb}$

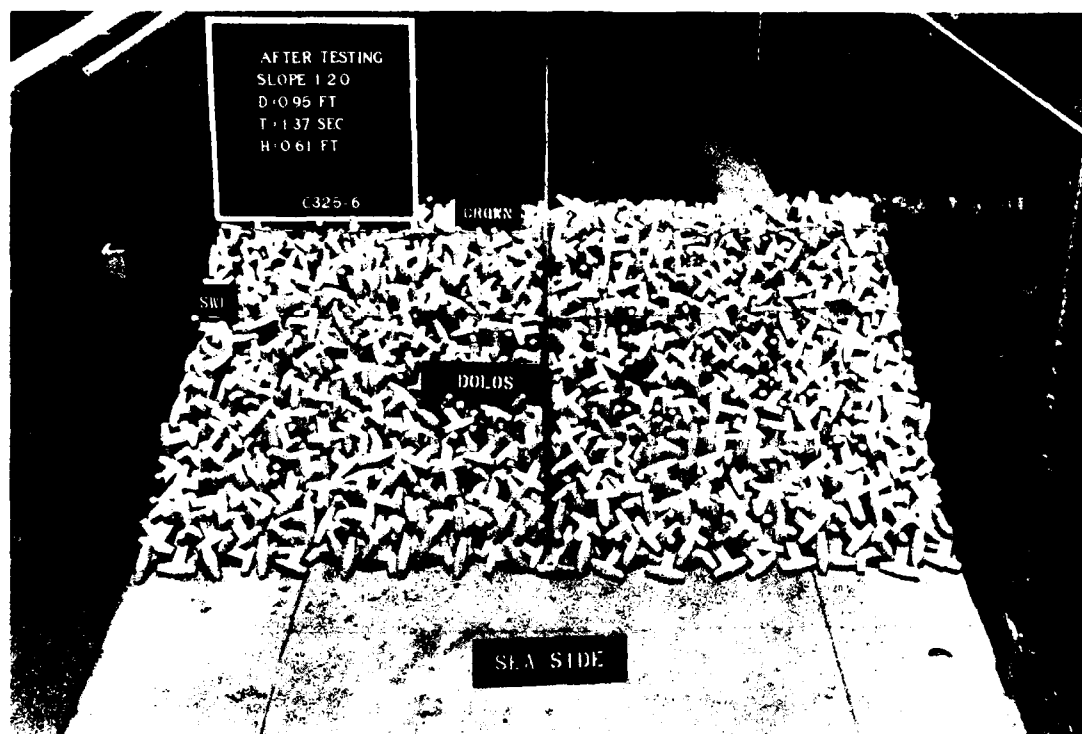
Photo 5. Sea-side view after attack of 1.37-sec, 0.61-ft waves; $d = 0.95$ ft; $W_a = 0.276$ lb; 1V-on-2H structure slope; dolos armor

Armor units were placed randomly in two layers and the number of armor units per given surface area was equal to that presently recommended for new construction in EM 1110-2-2904, "Design of Breakwaters and Jetties" (Headquarters, Department of the Army 1986). Photos 4-10 show typical after-testing conditions of structures.

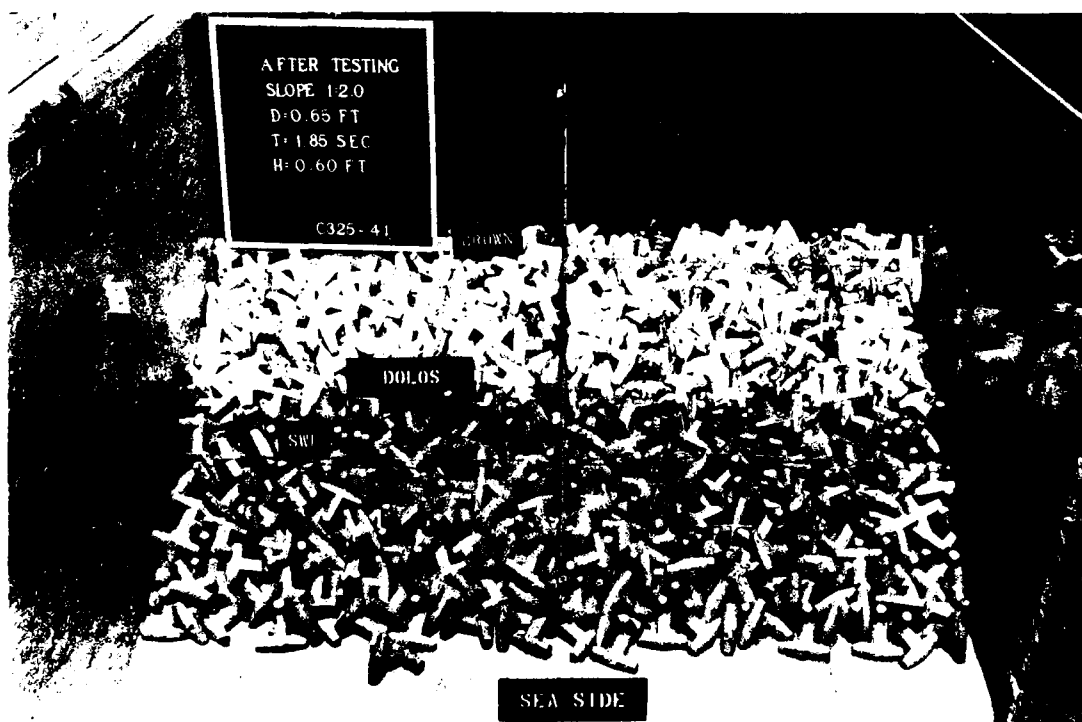
Photo 6. Sea-side view after attack of 1.85-sec, 0.60-ft waves; $d = 0.65$ ft; $W_a = 0.589$ lb; 1V-on-2H structure slope; dolos armor

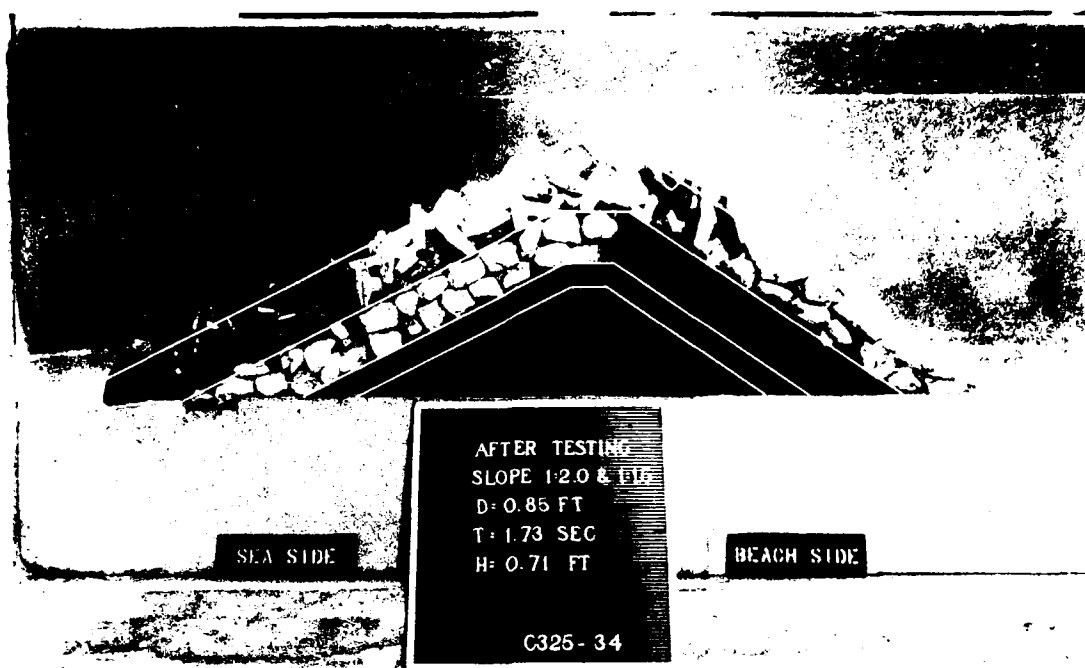
Photo 7. End view after attack of 1.73-sec, 0.71-ft waves; $d = 0.85$ ft;
 $W_a = 0.589$ lb; 1V-on-2H structure slope; dolos armor

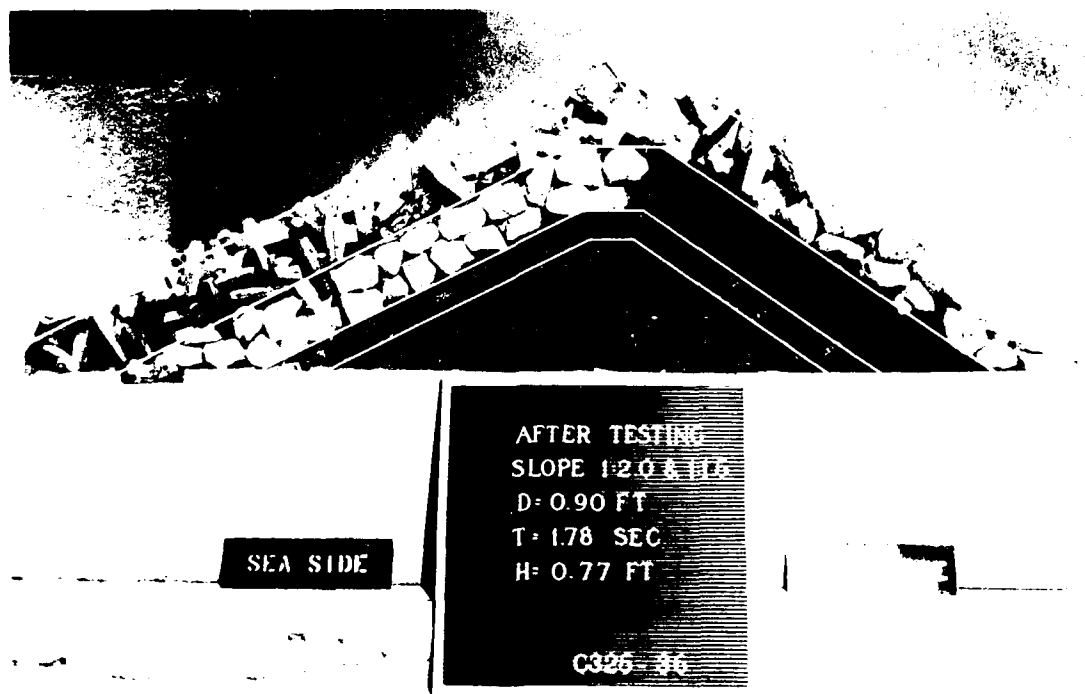
Photo 8. End view after attack of 1.78-sec, 0.77-ft waves; $d = 0.90$ ft;
 $W_a = 0.589$ lb; 1V-on-2H structure slope; dolos armor

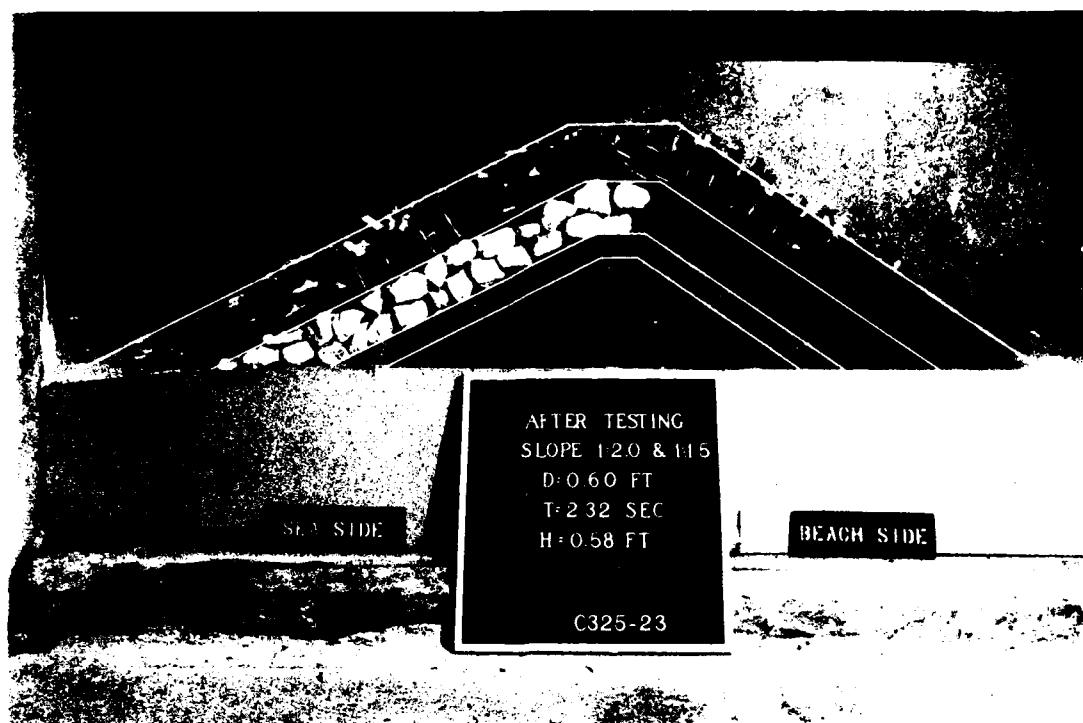
Photo 9. End view after attack of 2.32-sec, 0.58-ft waves; $d = 0.60$ ft; $W_a = 0.627$ lb; 1V-on-2H structure slope; tribar armor

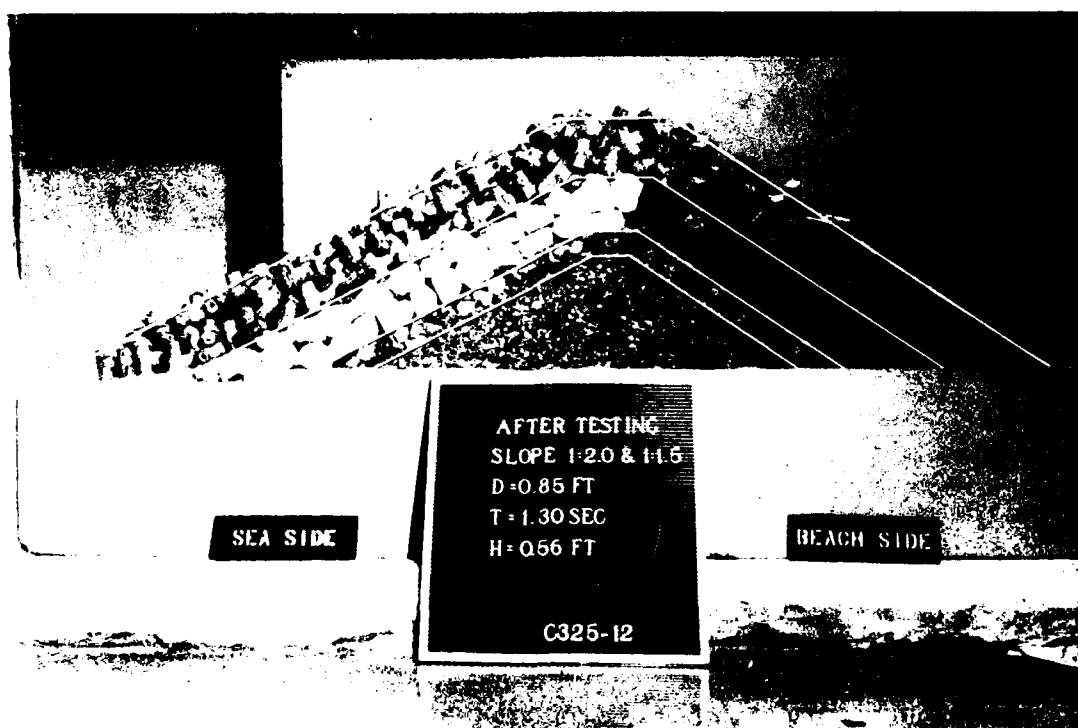
Photo 10. End view after attack of 1.30-sec, 0.56-ft waves; $d = 0.85$ ft; $W_a = 0.627$ lb; 1V-on-2H structure slope; tribar armor

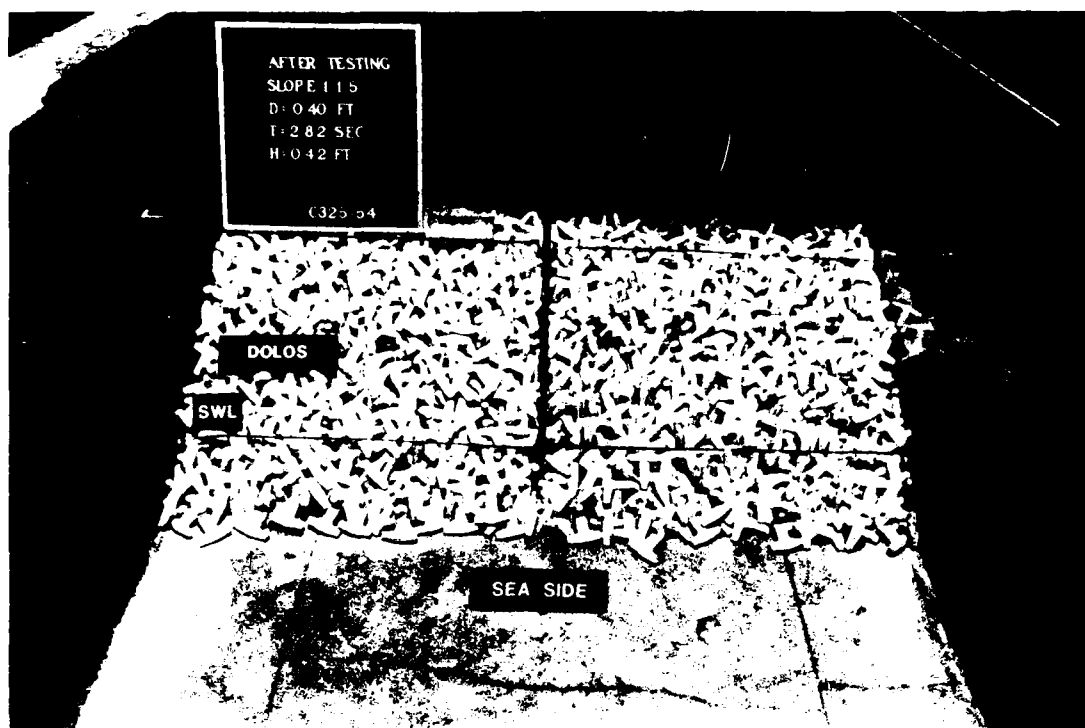
Photo 11. Sea-side view after attack of 2.82-sec, 0.42-ft waves; $d = 0.40$ ft; $W_a = 0.276$ lb; 1V-on-1.5H structure slope; dolos armor

in Table 2 and depicted in Photos 11-14, were similar to those obtained at the 1V-on-2H slope. However, a slight decrease in stability was observed.

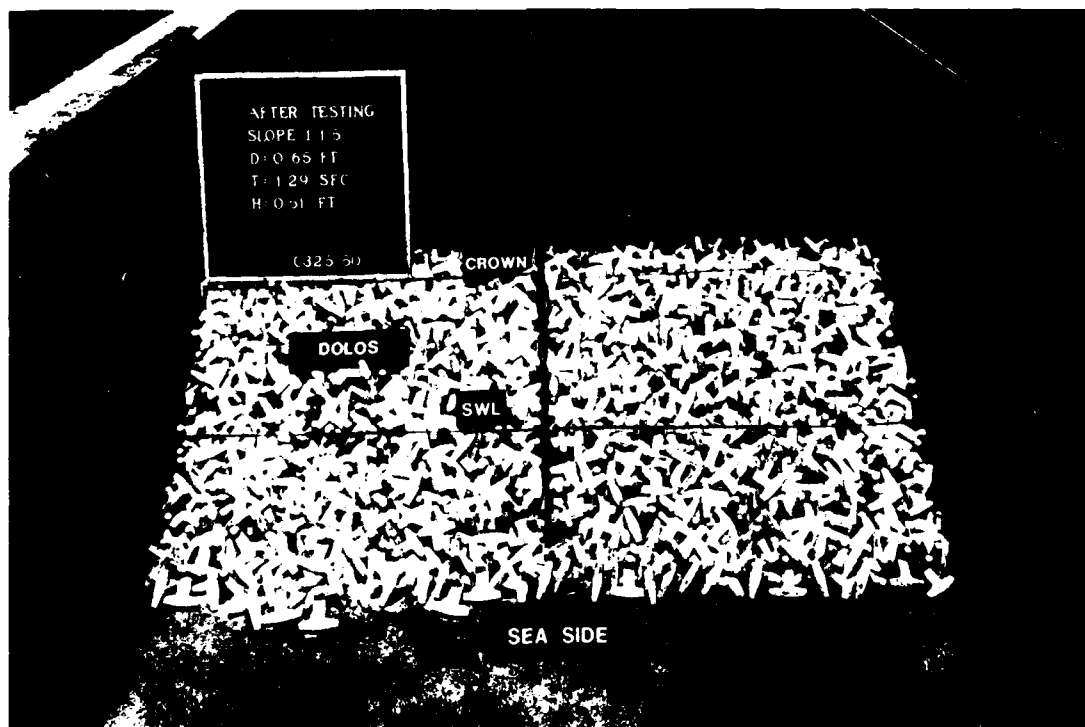
Photo 12. Sea-side view after attack of 1.29-sec, 0.51-ft waves; $d = 0.65$ ft; $W_a = 0.276$ lb; 1V-on-1.5H structure slope; dolos armor

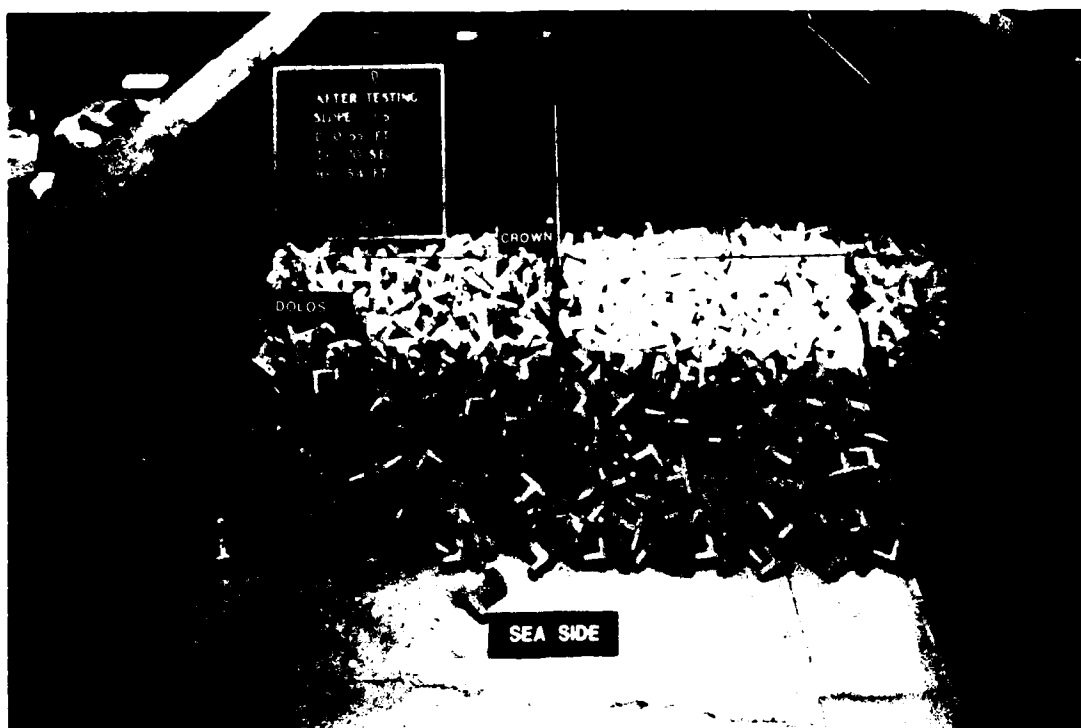
Photo 13. Sea-side view after attack of 1.70-sec, 0.54-ft waves;
 $d = 0.55$ ft; $W_a = 0.589$ lb; 1V-on-1.5H structure slope; dolos armor

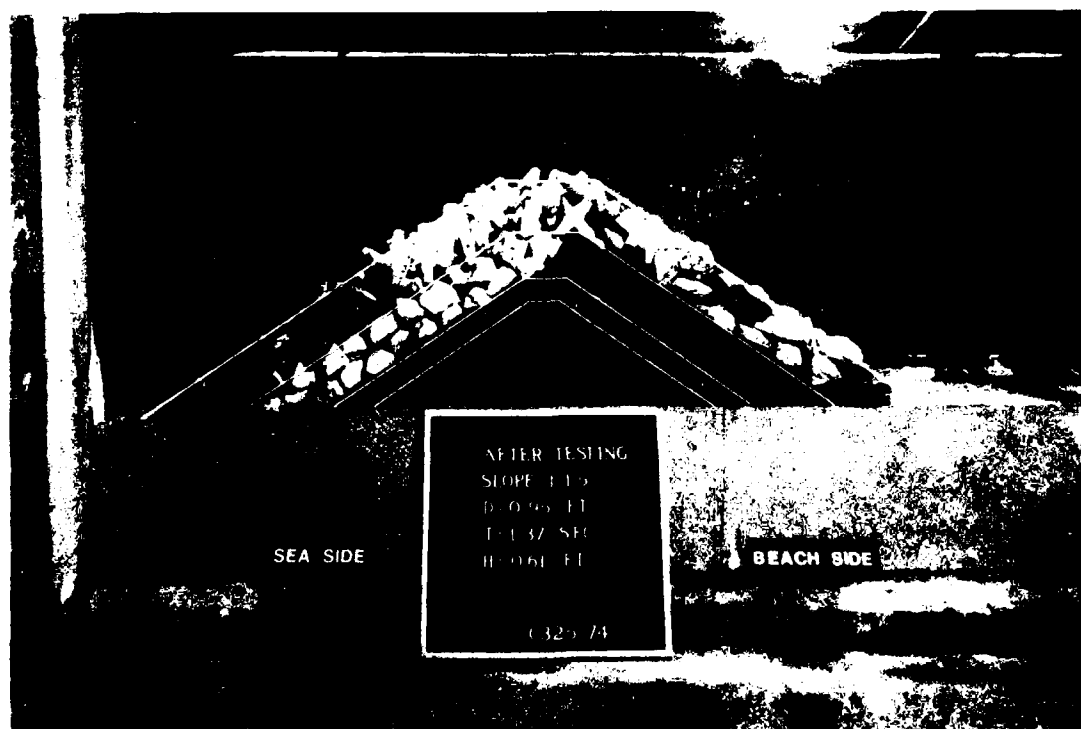
Photo 14. End view after attack of 1.37-sec, 0.61-ft waves;
 $d = 0.95$ ft; $W_a = 0.589$ lb; 1V-on-1.5H structure slope;
 dolos armor

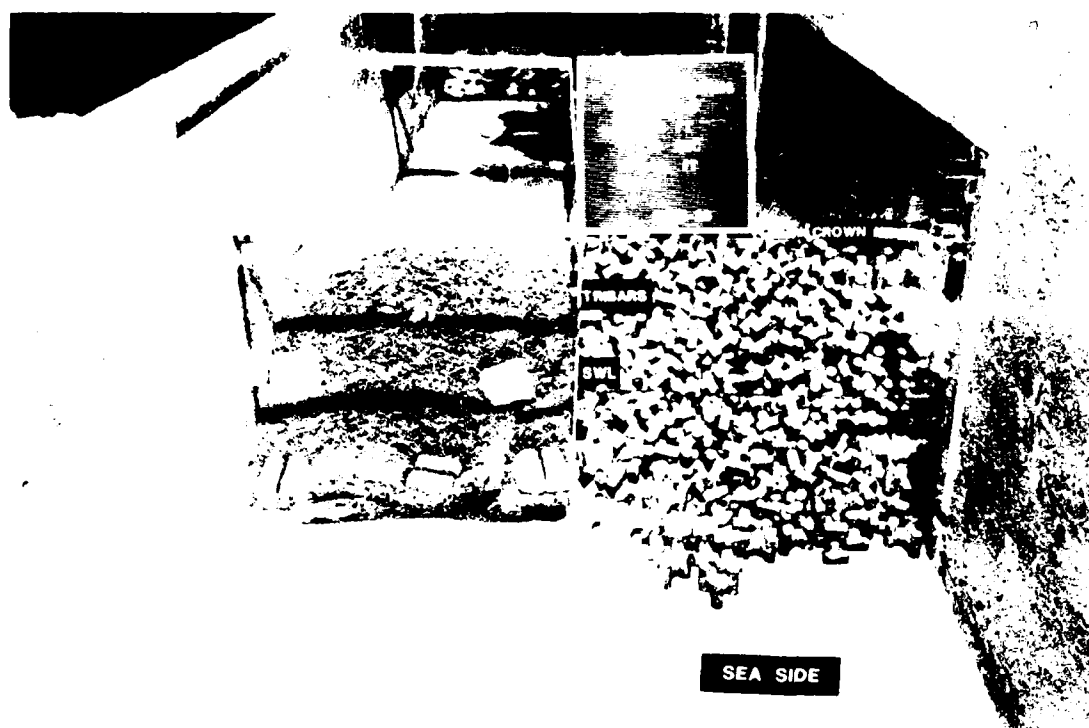
Photo 15. Sea-side view after attack of 1.18-sec, 0.38-ft waves;
 $d = 0.55$ ft; $W_a = 0.627$ lb; 1V-on-1.5H structure slope; tribar armor

22. Tribar tests were initiated with two layers of randomly placed units and an assumed K_D of 9. This structure proved to be unstable. Wave heights were progressively reduced to 0.33 ft without achieving stability. Generally, the tribars did not interface well with the larger armor stone at this steeper slope and were prone to downslope shifting. Photos 15 and 16 show the structure after attack of 0.38- and 0.33-ft waves, respectively. If stability had been achieved, the corresponding K_D 's would be 4.2 and 2.7. Based on these test results, randomly placed tribars are not recommended for overlaying existing armor stone at slopes steeper than 1V on 2H.

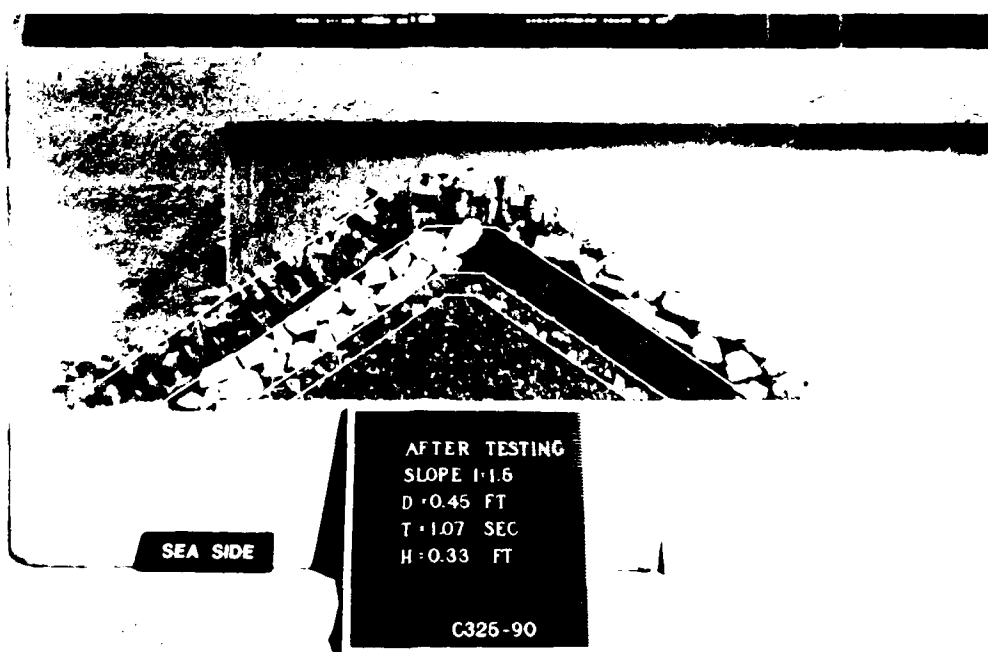
Photo 16. End view after attack of 1.07-sec, 0.33-ft waves;
 $d = 0.45$ ft; $W_a = 0.627$ lb; 1V-on-1.5H structure slope;
 tribar armor

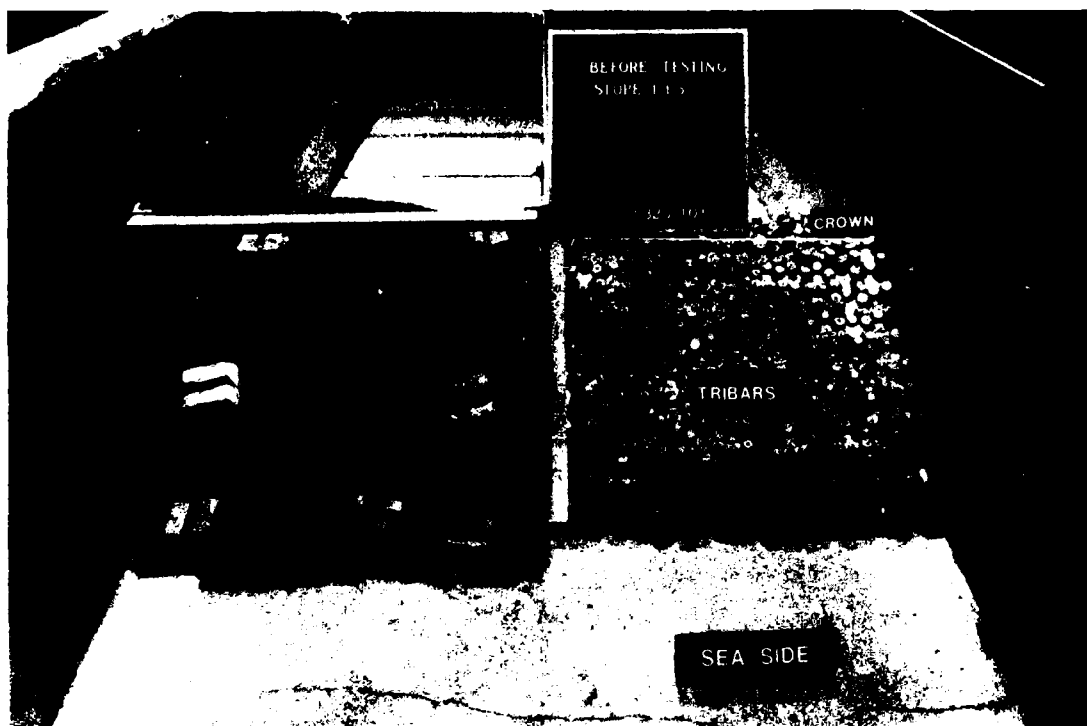
Photo 17. Sea-side view of uniformly placed tribar armor before wave attack at a 1V-on-1.5H structure slope

23. Random tribar placement was tested initially because this type is generally the most economical and reliable to construct in the field. However, one layer of uniform tribar placement in concert with large toe buttressing stone has been used by Pacific Ocean Division (POD). Therefore, it was decided to investigate the stability of this configuration. Based on POD's experience, a buttressing stone weight about 1.3 times greater than the tribar weight was selected. Photo 17 shows the structure before wave attack and Photos 18 and 19 show typical after-testing views.

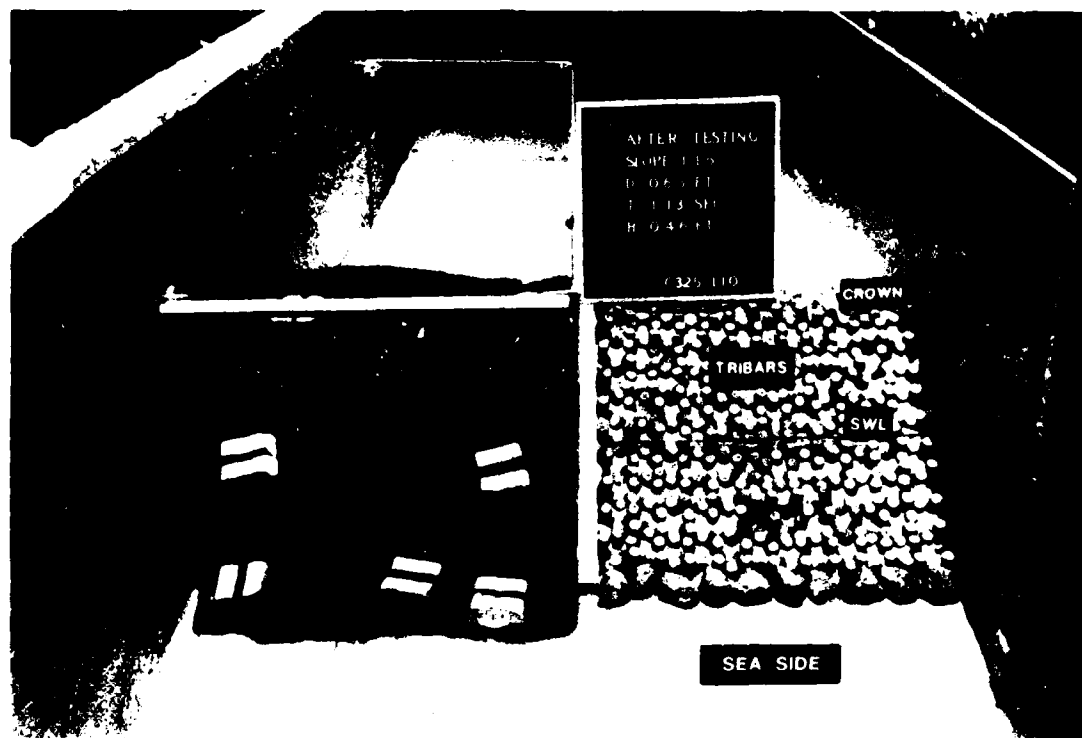
Photo 19. Sea-side view after attack of 1.13-sec, 0.46-ft waves; $d = 0.65$ ft; $W_a = 0.627$ lb; 1V-on-1.5H structure slope; uniformly placed tribars
